September 17, 2001

North American Region Number 01-18

*Ford Motor Company™*

# TECHNICAL SERVICE BULLETIN

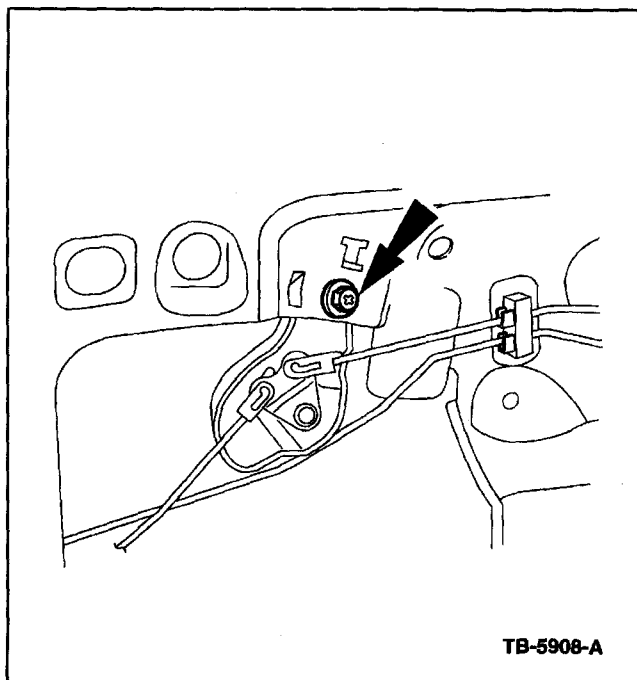
Figure 1 - Article 01-18-8

The power door locks may self-activate or cycle on some vehicles. This may be caused by a misadjusted front door lock linkage, excess solder in the front door power window switch, water infiltration of a potential open wire harness connector inside the front doors, wiring harness chafe on the door check strap, or a damaged Remote Keyless Entry (RKE) key fob.

1. Remove a front door trim panel by referring to the appropriate year Villager Workshop Manual, Section 501-05.
2. Position the watershield aside.
3. Loosen the lock rod bellcrank bolt (Figure 1).
4. Engage the front door latch into the closed position by closing the door or by manually closing the latch.
5. Manually lock the front door latch with the actuating rod.
6. Push and hold the lock knob in the locked position (Figure 2).
7. Tighten the lock rod bellcrank bolt to 5 N•m (44 lb-in).
8. Remove and replace the power window switch assembly (refer to Parts Block at the end of this article).
